ASSESSMENT

PHASE III  
- FINAL REPORTS -

**AIM III FINAL REPORTS**

**PLATFORM "C"**  
**INTACT AND DAMAGE CONDITION ASSESSMENTS**

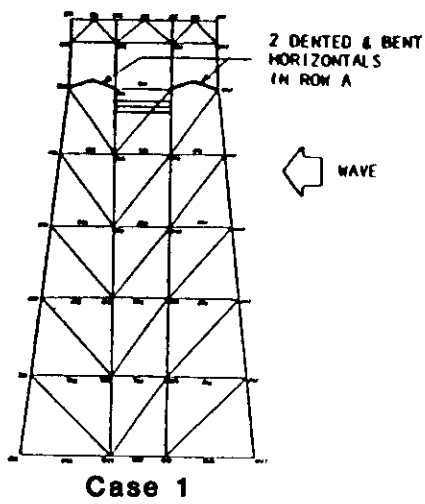
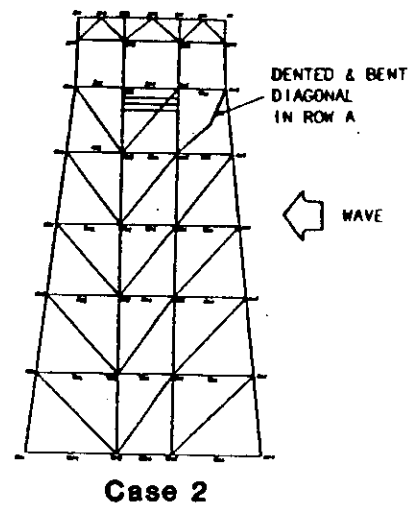
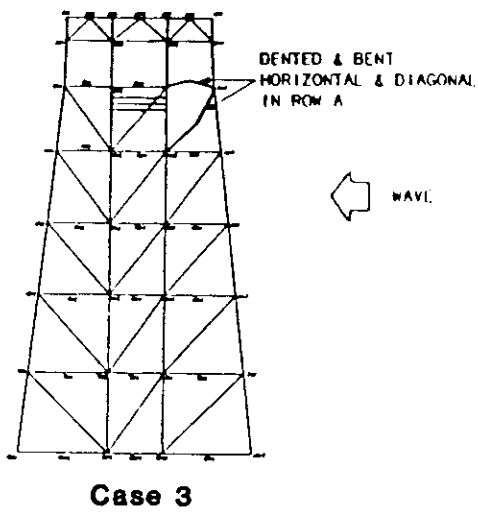
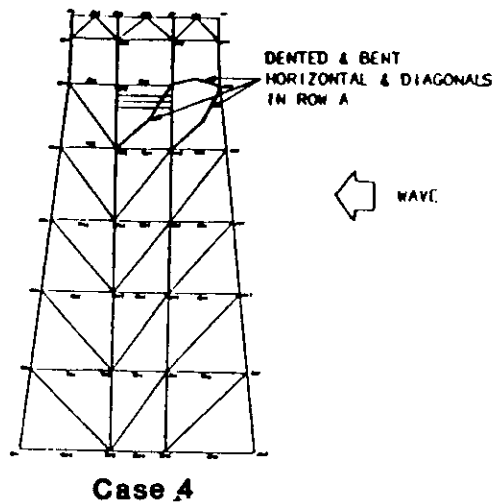
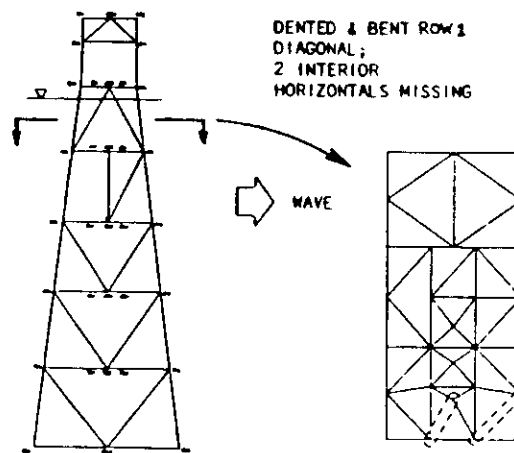
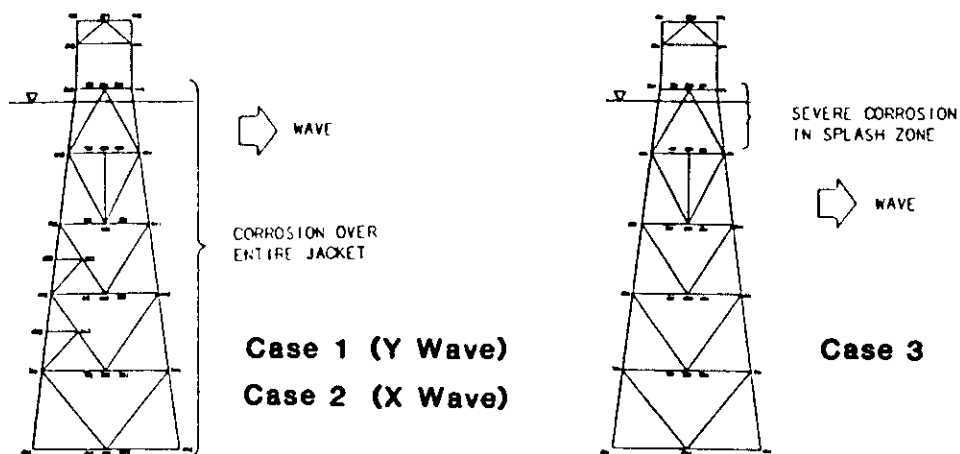
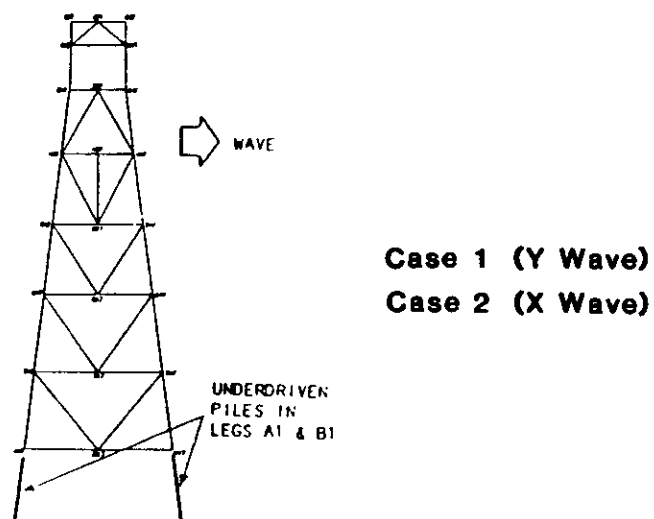
**FIGURE 2-1 SUMMARY OF DAMAGED CASES**

**Damaged Members Near Waterline:** Bent and dented members caused by workboat impacts. Platform capacity dropped by about 5 to 15 percent depending primarily upon the number of damaged members.

**Damage Near Base of Jacket:** Completely severed members caused by dropped objects from topside operations. Platform capacity dropped by about 10 to 12 percent.

**Interior Horizontal Damage with Diagonal Damage:** Missing interior horizontals and a damaged transverse diagonal near the platform's midpoint. Platform capacity dropped by about 20 percent. The damaged diagonal contributed to most of capacity reduction.

**Corrosion Damage:** This case considered overall platform corrosion and localized corrosion in the splash zone. The overall corrosion was the worst damage case considered, resulting in a 35 percent drop in capacity. The localized corrosion case resulted in a 20 percent drop in capacity.

**Foundation Defects:** Two piles on one of the end transverse bays were considered to be underdriven by 120 feet (out of 270 ft). The capacity dropped from 5 to 17 percent depending upon loading direction.

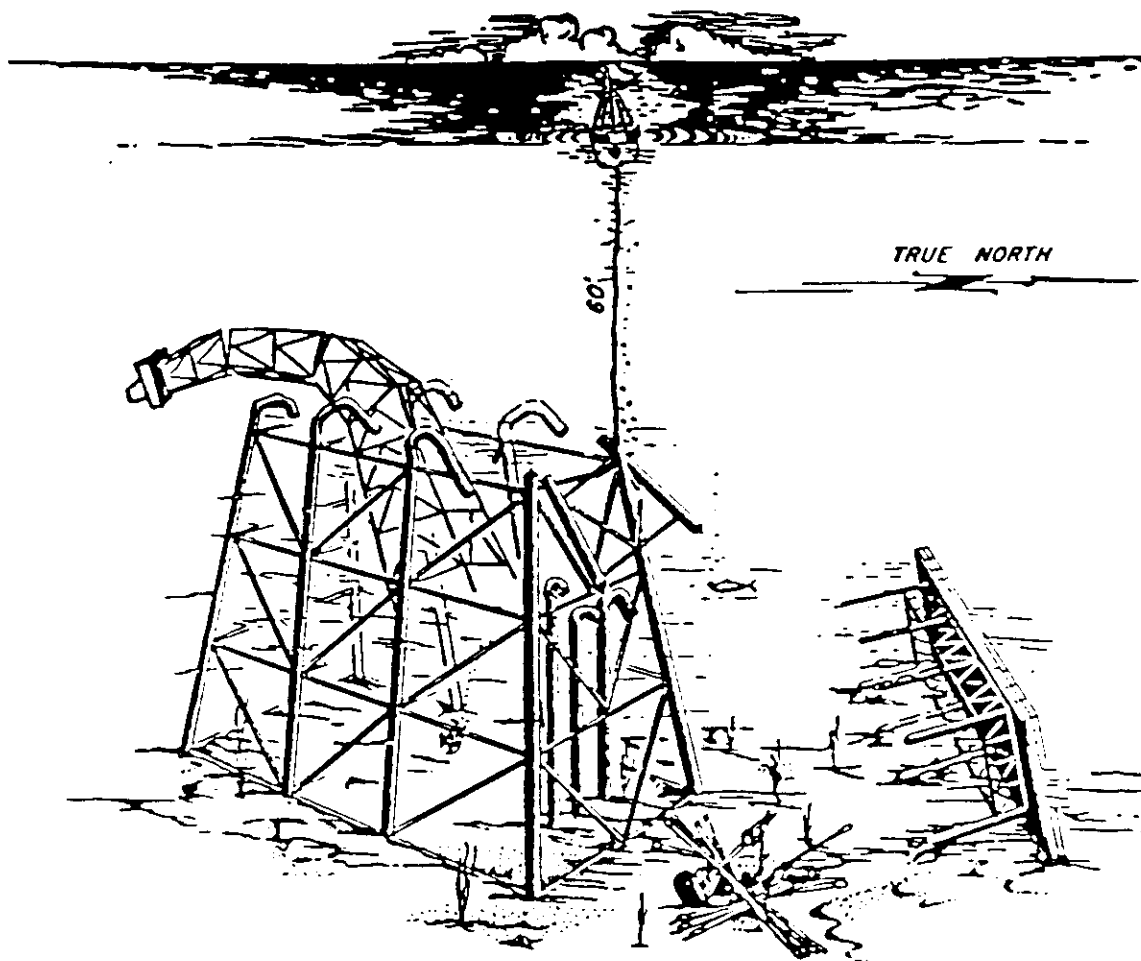
**FIGURE 7-13**

**STORM DAMAGE TO EXAMPLE PLATFORM**

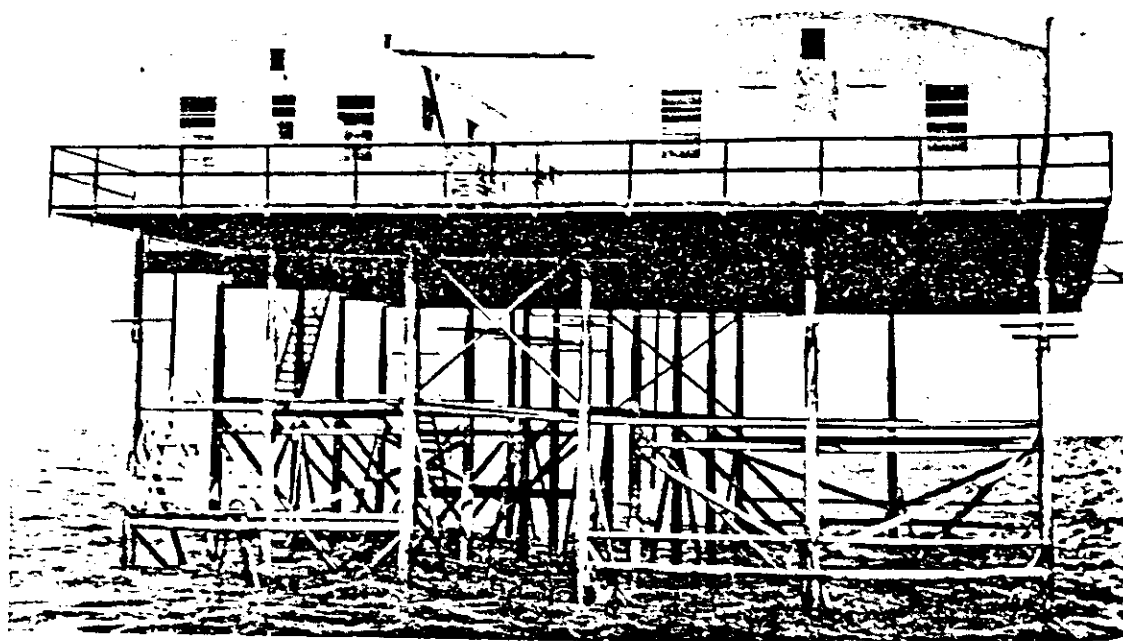
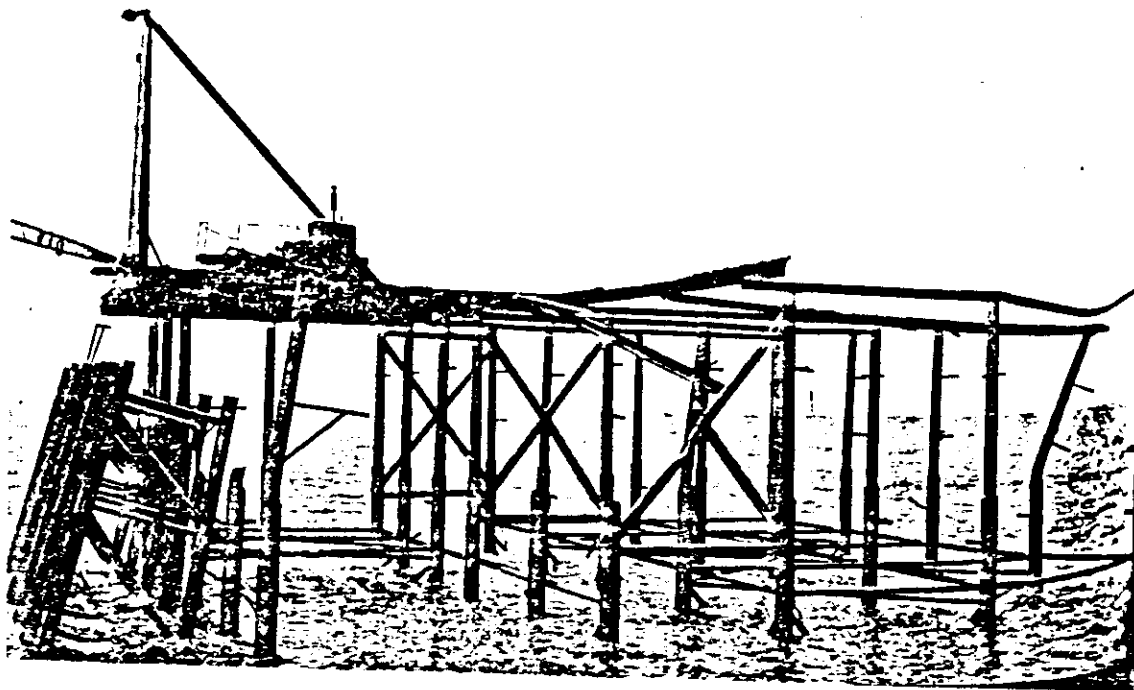
FIGURE 4-2

This photo is of the quarters platform at The Ohio's first offshore test. This platform is almost identical to the one swept by the hurricane. Principal difference was the placing of a stiff leg derrick on the second platform instead of a fuel tank as on the first.

In sharp contrast to the photo above is this view of the quarters platform after the storm had stripped it of the 65 x 30 x 13 foot high, 85 ton bunk house and the 40 x 19 x 13 foot, 35 ton galley. The dolphin was tilted into the structure, the ladders and walkaways ripped away, and the 8-inch I-beams twisted. Note the 10 3/4-inch pile bent at a point just above the weld to the 14-inch O. D. jacket. Damage to the stiff leg derrick and engine was negligible.

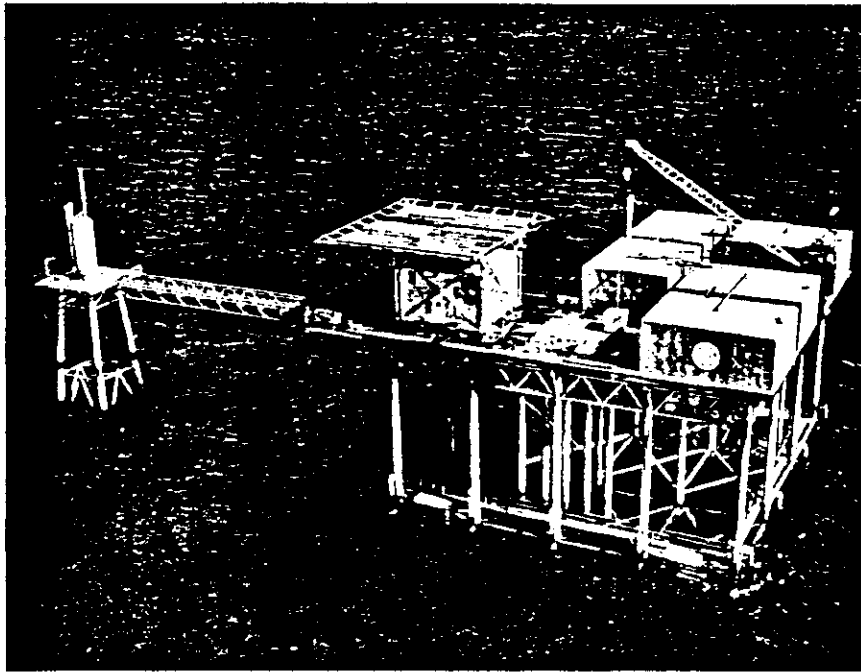
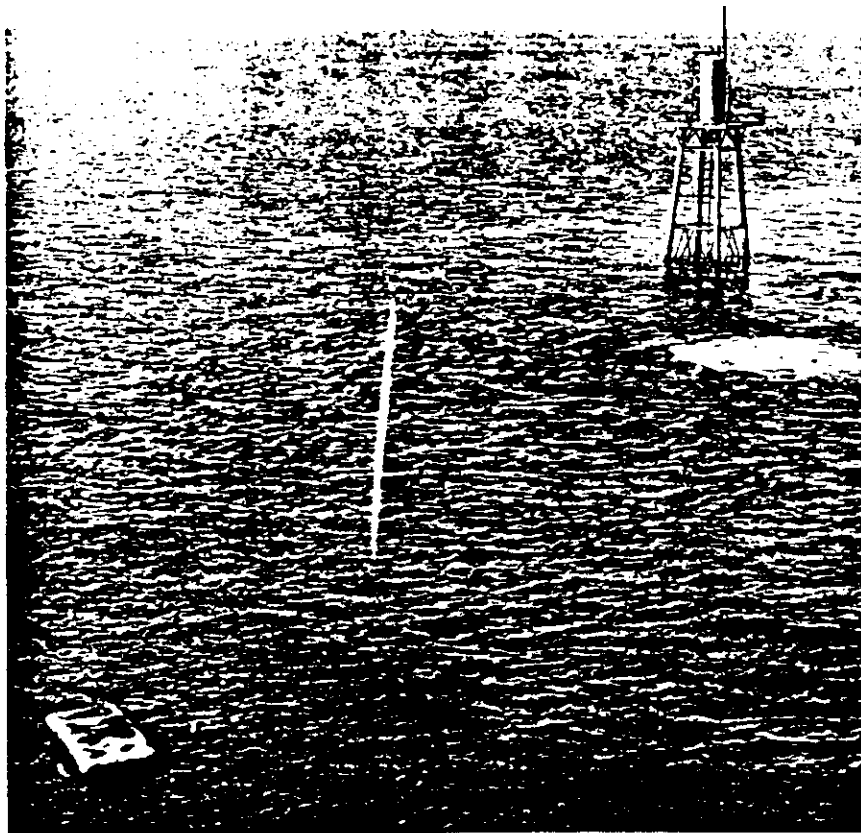
Production platform in Eugene Island area with five wells and storage facilities was completely destroyed. Photo at top shows installation before Hilda. After storm (bottom), only small treater platform remains intact. Disturbed water adjacent to treater platform is due to broken flow line or leakage from well bore.

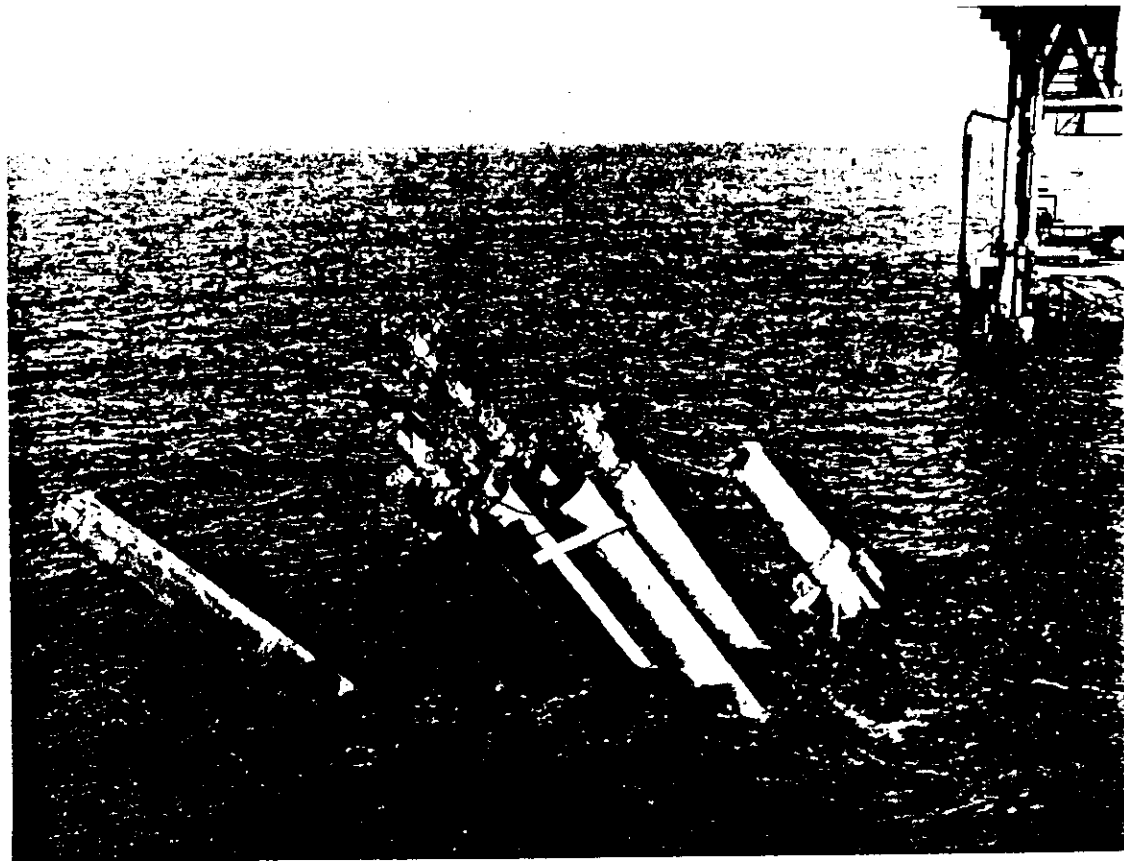
**SHIP SHOAL 169**

**SHEARED PLATFORM** is in Block 169, Ship Shoal area. Only the piles of Gulf Oil Corp.'s five-well platform remain above the surface.

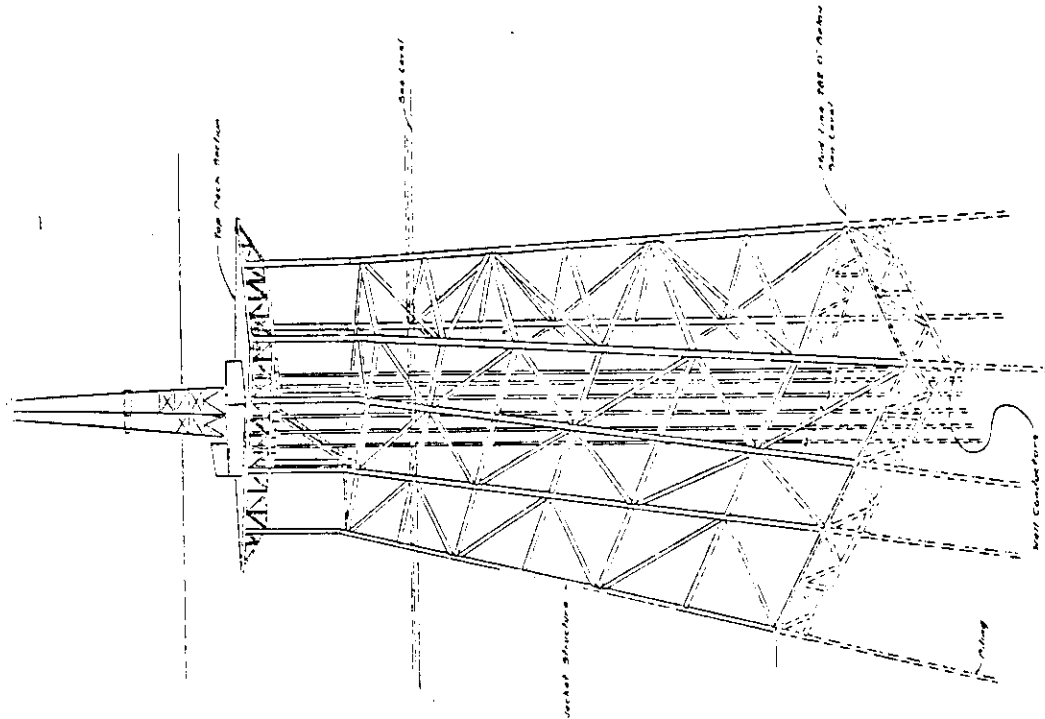
DAMAGED PLATFORM

PLATFORM TWISTED AND PUSHED TO A 55 DEGREE LIST  
AND DOWN TO 10 FEET UNDERWATER DUE TO MUDSLIDE.  
SMALL GAS LEAK, NO OIL SPILLED.

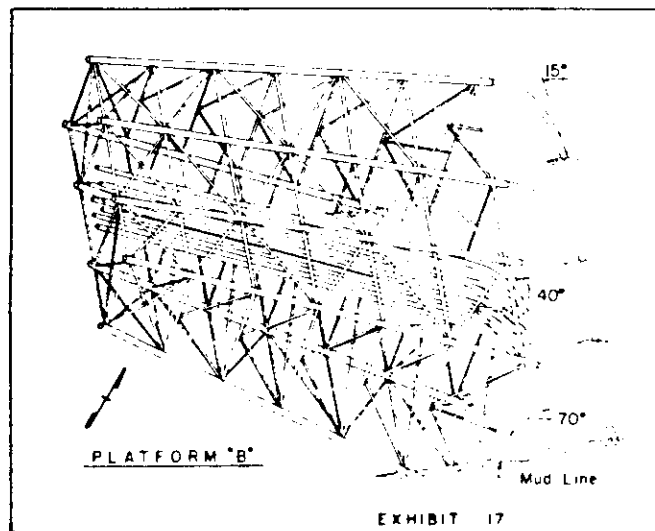
EXHIBIT 17

DAMAGED PLATFORM
